Camas Creek Subbasin Five-Year Review

HUC 17040220

**State of Idaho
Department of Environmental Quality**

December 2016

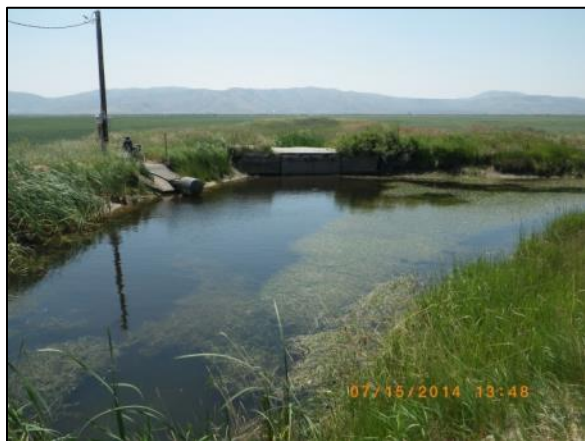
1. ID17040220SK020_03 is spatially represented to be associated with Camas Creek (US-18) rather than Negro Creek. The actual spatial extent of this AU needs ground-truthing to support the appropriate change in ADB.
2. ID17040220SK020_02 is ephemeral, flowing in direct response to snowmelt and precipitation.
3. An irrigation storage reservoir near Wildhorse Road entrains surface flows on the upper reaches of this AU. These waters are conveyed in the Negro Creek channel during the irrigation season until the storage is depleted. Downstream irrigation flow is captured then pumped from an in-channel pond below sample site 17040220-20A (Old Highway 68) (Figure 102). All irrigation flow is used at this pump; zero surface flow reaches the Camas Creek channel except during periods of seasonal runoff.

Figure 102. Irrigation pond at 17040220-20A.

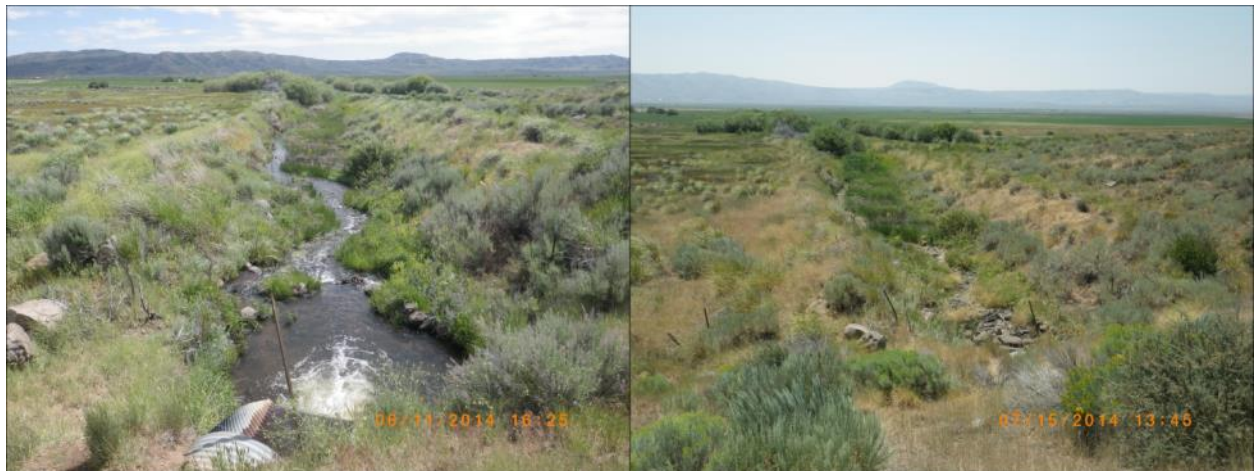
DEQ visited this water body from April 2014 through September 2014 (Figure 104). These efforts included composite grab samples for lab analysis of ammonia, TKN, TN, TP, TSS, and *E. coli*. When possible, flows were measured to allow for instantaneous pollutant load calculations (Table 139).

Figure 104. Sample site 17040220-20B, 6/11/2014 and 7/09/2014.

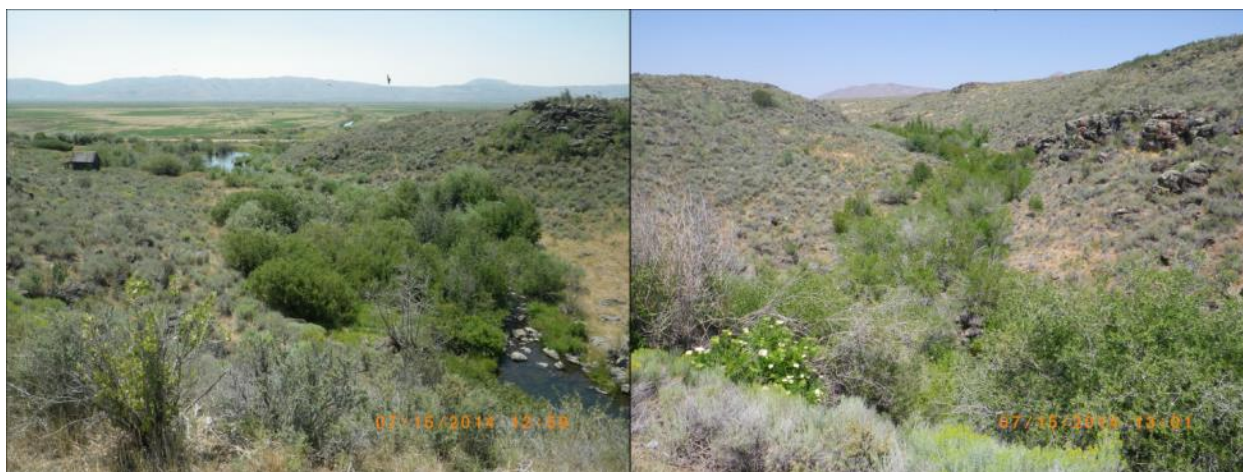
1. All segments of ID17040220SK021_02 are ephemeral.
2. ID17040220SK021_03 has distinct perennial and ephemeral segments (Figure 106).
3. The source of the perennial flow in ID17040220SK021_03 is unknown. Although small in volume, this surface flow persisted through the summer. Surface flow begins at the head of the canyon near Wildhorse Road then continues south under Highway 20. Full infiltration of the summer flow occurs prior to the channel crossing at Old Highway 68.
4. Active beaver complexes exist at both upper and lower ends of the 3rd-order canyon.

Figure 106. ID17040220SK021_03, downstream/upstream, 7/15/2014.

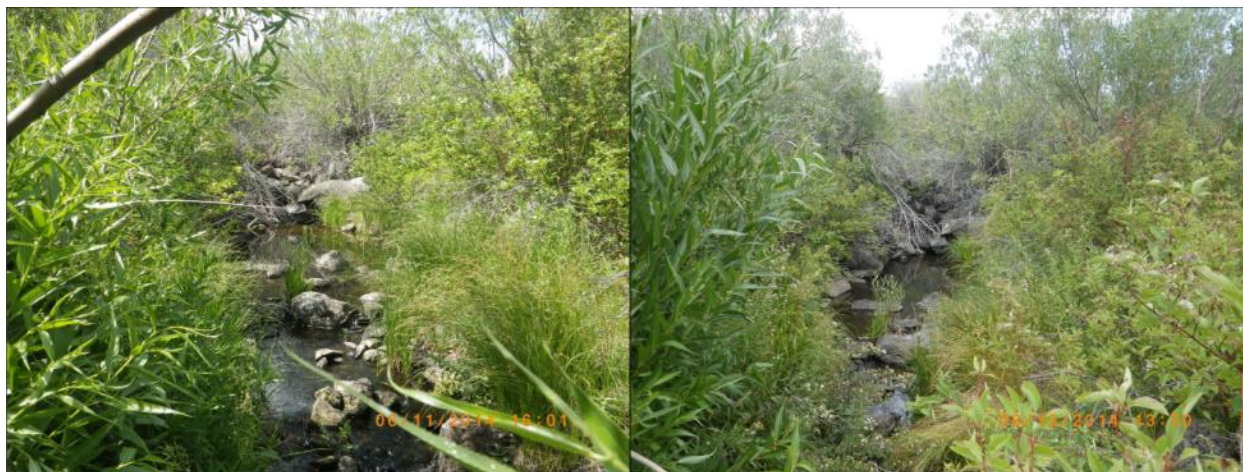
DEQ sampled this water body from April 2014 through September 2014 (Figure 108). These efforts included composite grab samples for lab analysis of ammonia, TKN, TN, TP, TSS, and *E. coli*. When possible, flows were measured to allow for instantaneous pollutant load calculations (Table 144).

Figure 108. Sample site 17040220-21B, 6/11/2014 and 8/12/2014.

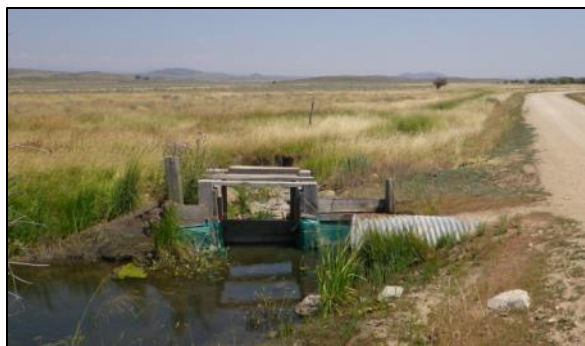
1. All stream reaches in ID17040220SK022_02 are ephemeral.
2. The upper and lower extents of ID17040220SK022_03 are ephemeral.
3. The middle portion of ID17040220SK022_03 maintains perennial flow due to a spring at the base of the west-end slopes. During the growing season, this flow is 100% diverted for irrigation (Figure 111). Except during spring runoff, undiverted flow infiltrates to ground water prior to reaching Camas Creek.

Figure 111. Malad River diversion, 7/15/2014.

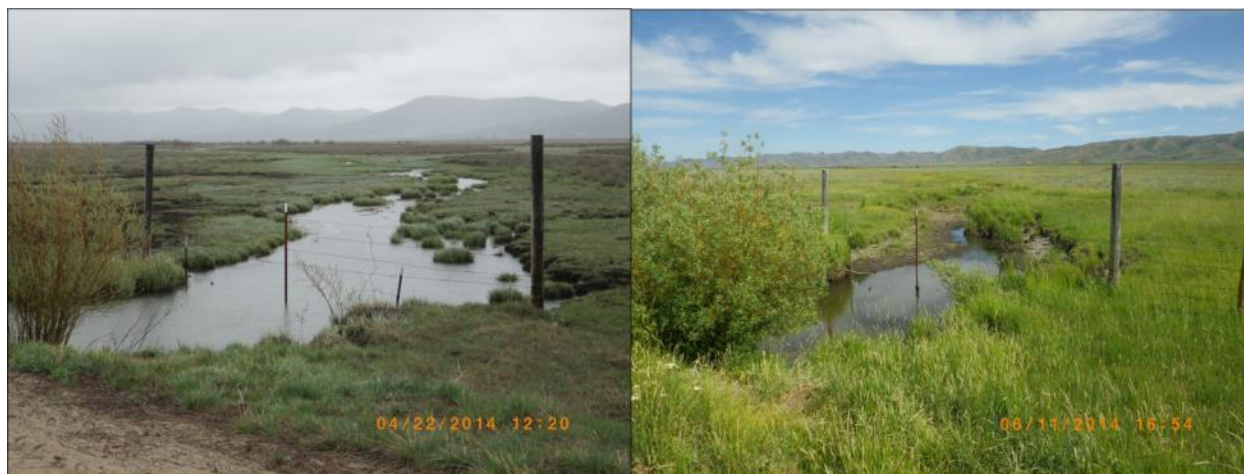
DEQ visited this water body from April 2014 through September 2014 (Figure 113). These efforts included composite grab samples for lab analysis of ammonia, TKN, TN, TP, TSS, and *E. coli*. When possible, flows were measured to allow for instantaneous pollutant load calculations (Table 152).

Figure 113. Sample site 17040220-22A, 4/22/2014 and 6/11/2014.

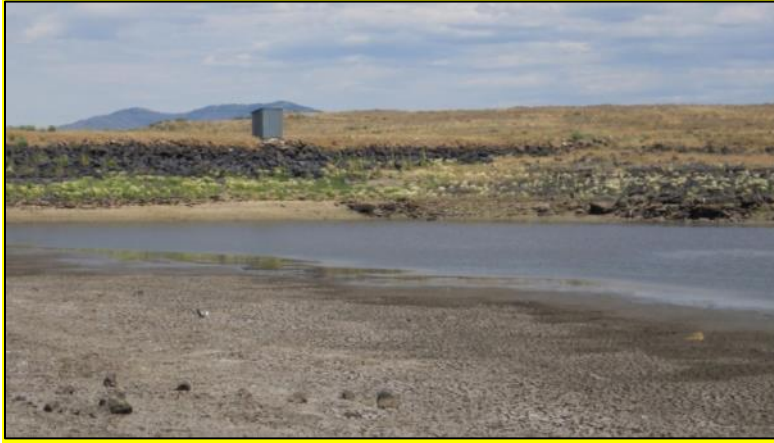
Figure 115. Mormon Reservoir, 7/09/2014. Water level is below the reservoir drain with only a shallow puddle remaining.

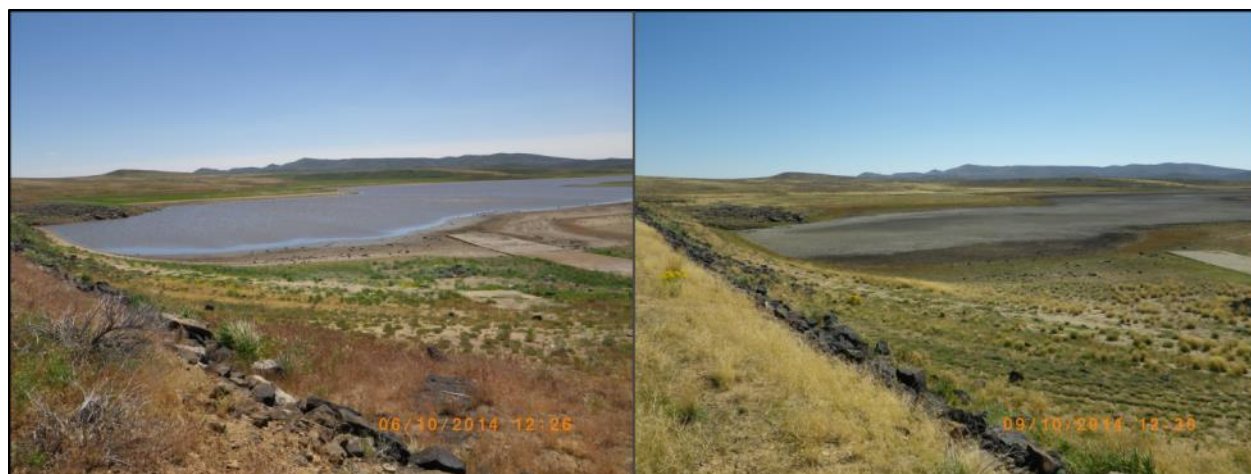
DEQ visited this water body for sampling from April 2014 through September 2014 (Figure 116). These efforts included composite grab samples for lab analysis of ammonia, TKN, TN, TP, TSS, and *E. coli* (Table 157).

Figure 116. Mormon Reservoir looking southeast from the dam, 6/10/2014 and 9/10/2014.

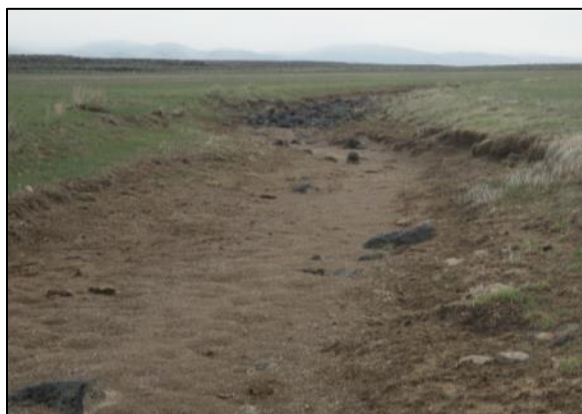
1. All stream segments comprising AU ID17040220SK024_02 are ephemeral.
2. Dairy Creek flow-connects to Mormon Reservoir only during periods of extreme runoff. Spring runoff in 2014 did not produce a volume sufficient to contribute to Mormon Reservoir (Figure 118). Normally, Dairy Creek flows infiltrate prior to reaching the reservoir.

Figure 118. Dairy Creek near Mormon Reservoir, 4/22/2014.

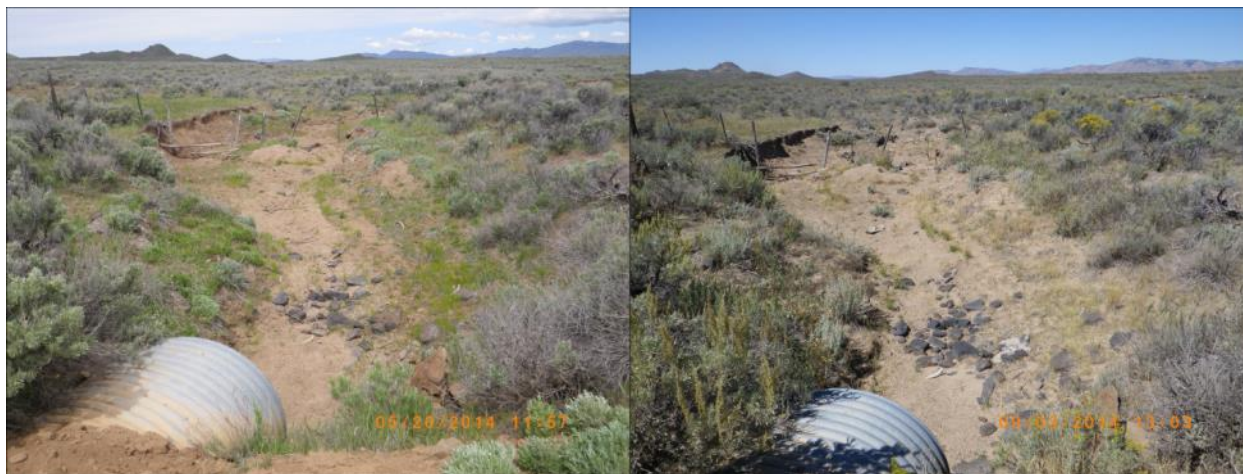
Figure 120. 17040220-24A, 5/20/2014 and 9/03/2014.

DEQ visited this water body for sampling from April 2014 through September 2014 (Figure 120). These efforts included composite grab samples for lab analysis of ammonia, TKN, TN, TP, TSS, and *E. coli*. When possible, flows were measured to allow for instantaneous pollutant load calculations (Table 159).

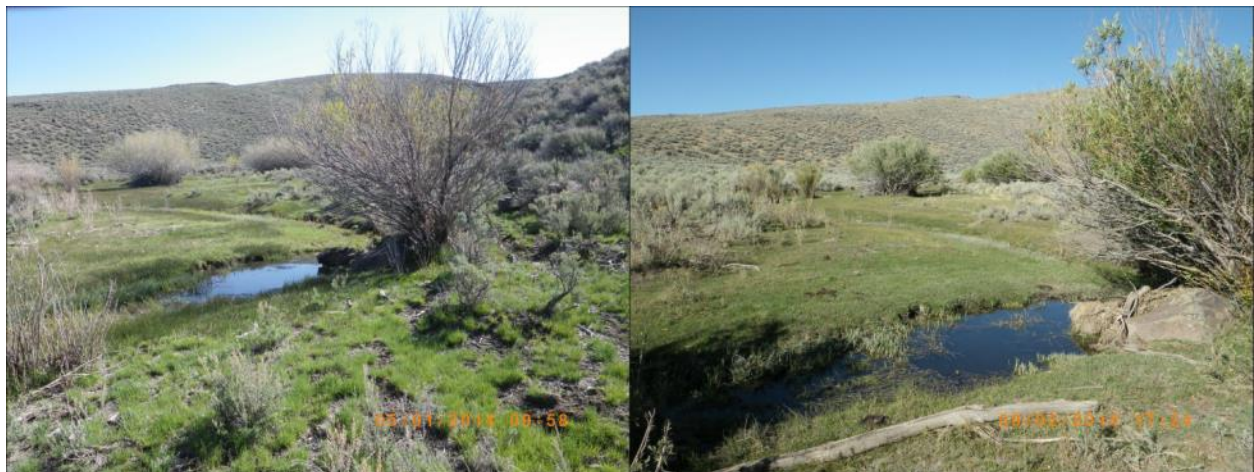
Figure 123. 17040220-25A, 5/01/2014 and 9/02/2014.

DEQ visited this sampling location from April 2014 through September 2014 (Figure 123). These efforts included composite grab samples for lab analysis of ammonia, TKN, TN, TP, TSS, and *E. coli*. When possible, flows were measured to allow for instantaneous pollutant load calculations (Table 166).

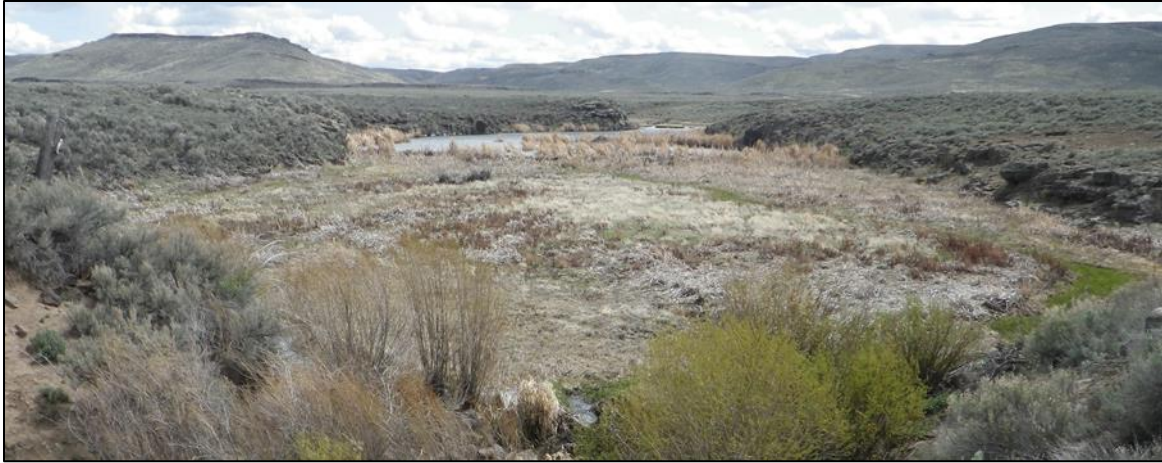
Figure 126. Failed reservoir in AU ID17040220SK026_03. View from dam looking upstream (south).

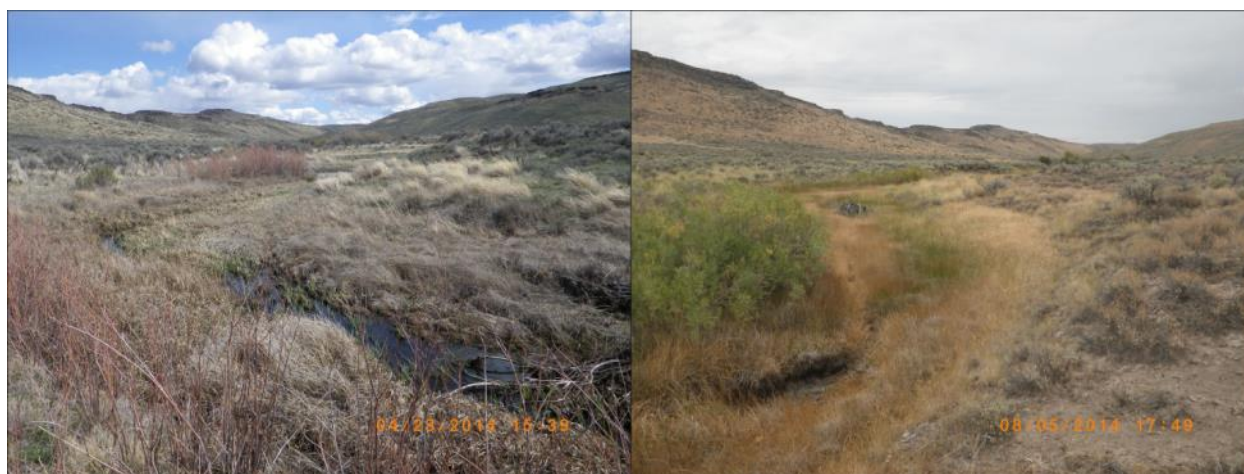
DEQ sampled this water body from April 2014 through September 2014 (Figure 128). These efforts included composite grab samples for lab analysis of ammonia, TKN, TN, TP, TSS, and *E. coli*. When possible, flows were measured to allow for instantaneous pollutant load calculations (Table 173).

Figure 128. Sample site 17040220-26A, 4/28/2014 and 8/05/2014.

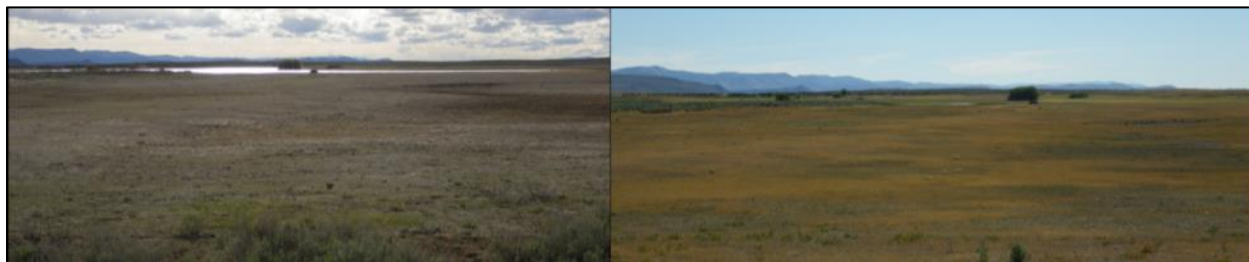
DEQ visited this water body for sampling from April 2014 through September 2014 (Figure 131). Grab samples were collected for lab analysis of ammonia, TKN, TN, TP, TSS, and *E. coli* (Table 178).

Figure 131. Kelly Reservoir (US-27), 4/23/2014 and 7/01/2014.
